CHARLES RIVER BASIN
NEWTON, MASSACHUSETTS

WABAN HILL RESERVOIR DAM
MA 01111

PHASE I INSPECTION REPORT
NATIONAL DAM INSPECTION PROGRAM

FEBRUARY 1980

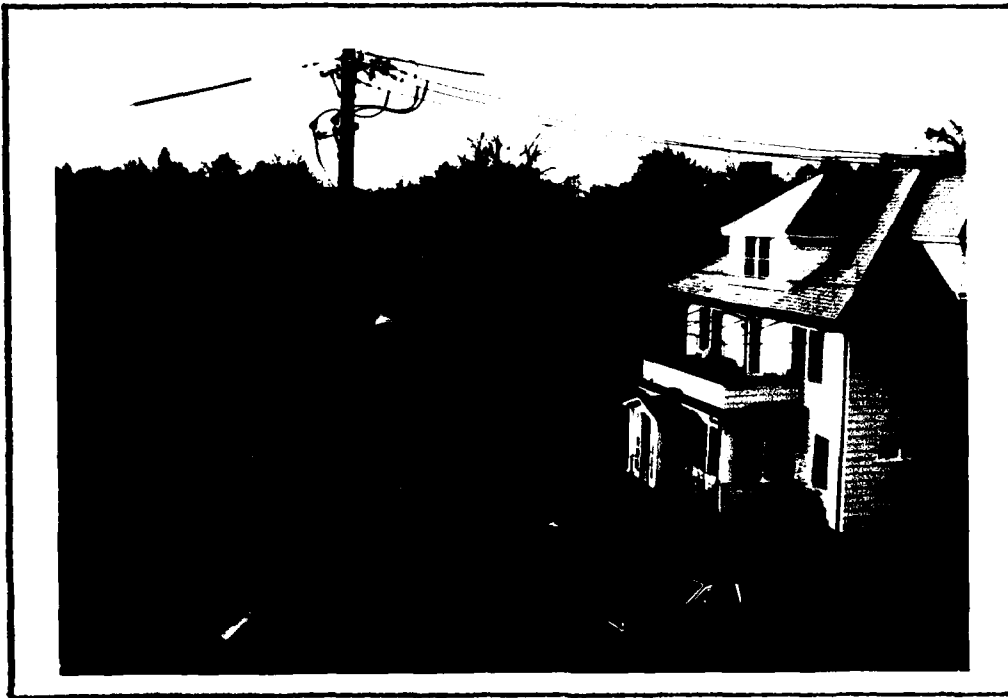
11. POTENTIAL HAZARD AREA ALONG THE SOUTH SIDE OF THE RESERVOIR.
(10/23/79)

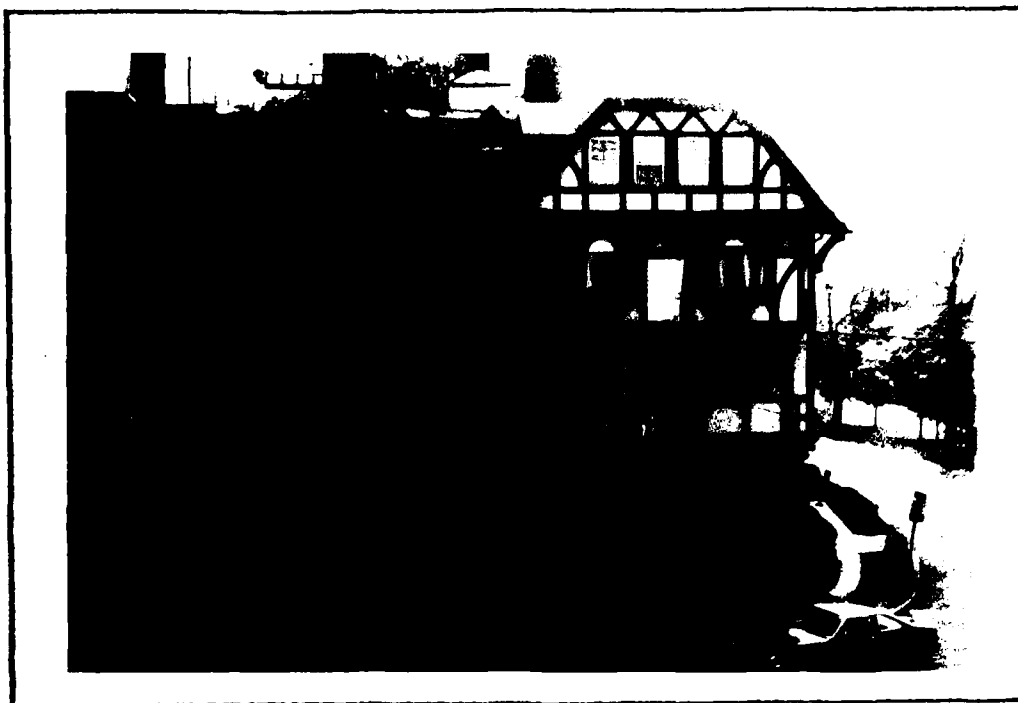
9. POTENTIAL HAZARD AREA ALONG THE EAST SIDE OF THE RESERVOIR.
(10/23/79)

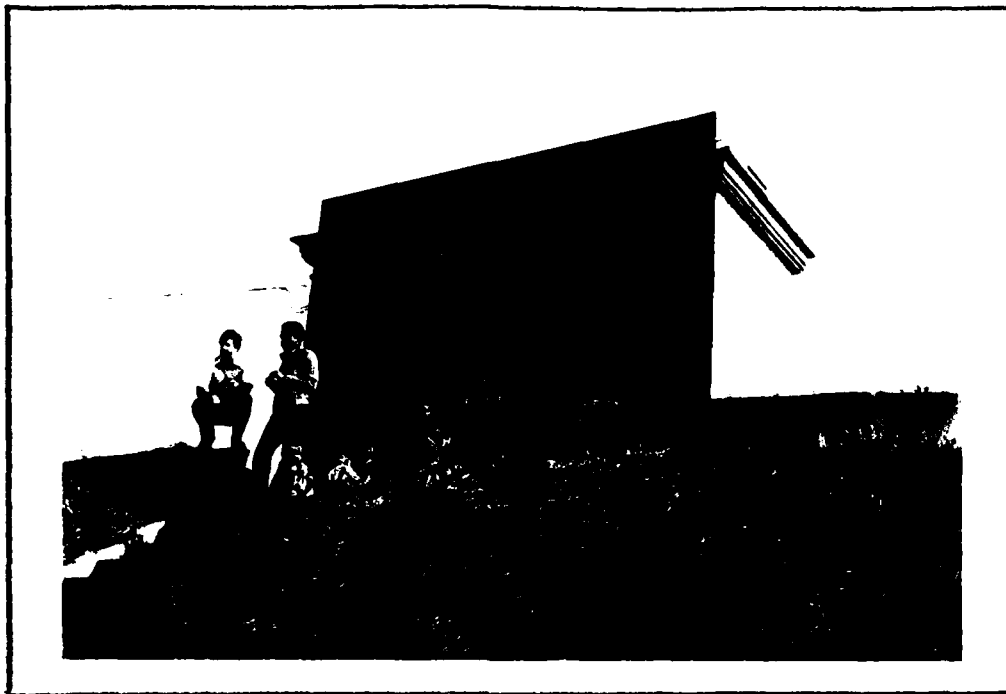
5. CONCRETE RETAINING WALL, GATEHOUSE AND OUTSIDE SLOPE AT THE SOUTHWEST CORNER OF THE RESERVOIR. (10/23/79)
